SITE ASSESSMENT REPORT
FOR
LINDSAY LIGHT COMPANY SITE
U.S. EPA ID: N/A

SSID#: N/A TDD: T05-9305-014 PAN: EIL0794SAA

August 2, 1993

ecology and environment, inc.

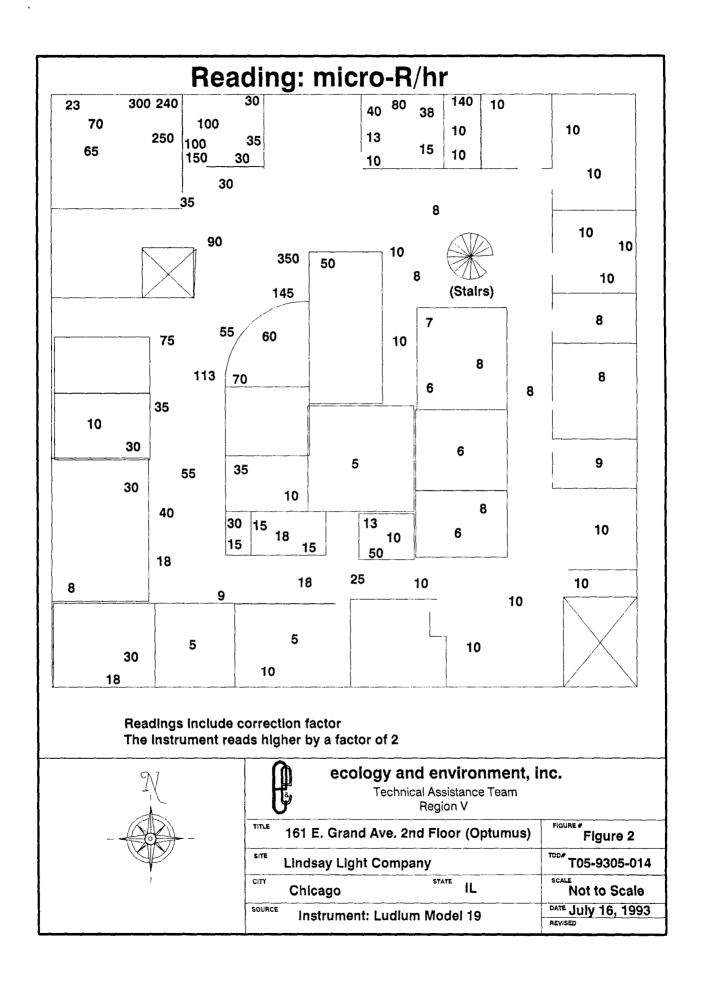
At 1900 hours, Group 2 conducted the survey on the second floor. The northwest corner office had high readings of up to 300 micro-R/hr. A window of the east adjacent room from the corner office had readings of 80 micro-R/hr (See Figure 2 for second floor results).

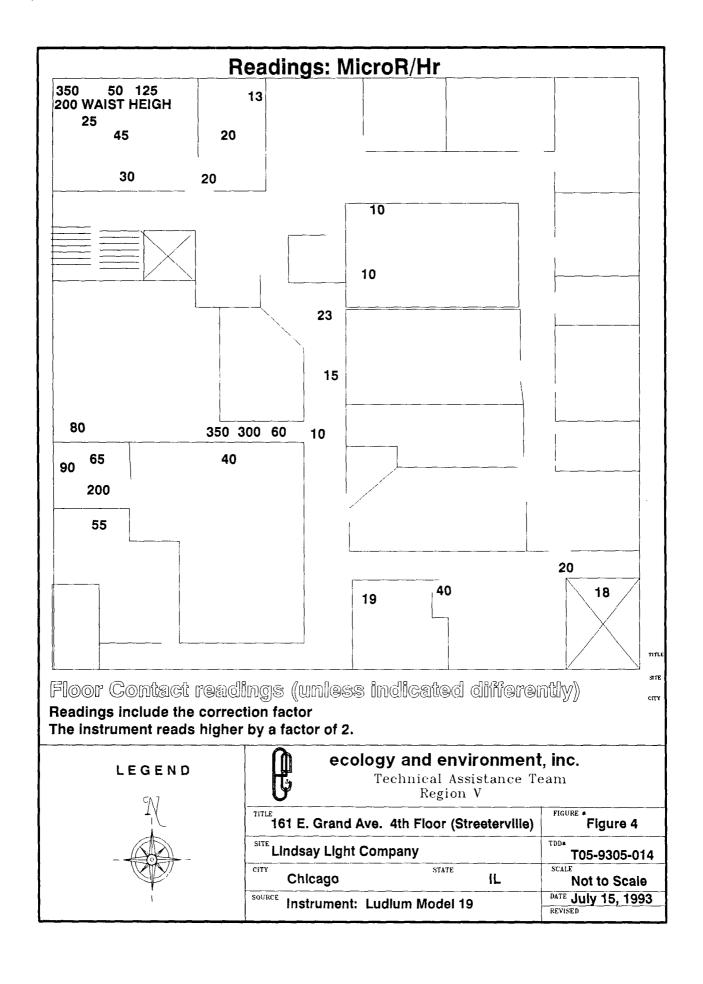
At 1830 hours, group 1 began surveying the fourth floor. Group 1 could only perform a partial survey on the fourth floor due to the recording session in the booth located on the east section of the floor. The area where work was performed by the building owners contractor in 1987 to remove an area of contaminated material, had a reading of 350 micro-R/hr at floor contact and 200 microR/hr waist high (See Figure 4 for fourth floor results).

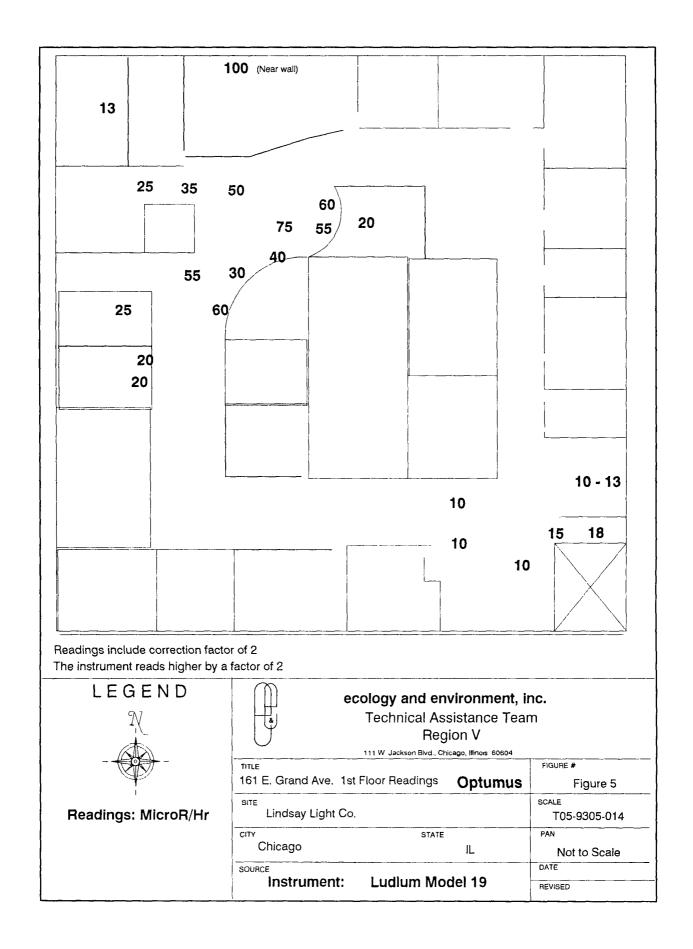
secretary area in the northwest corner of the floor. The reading near the secretary was 100 micro-R/hr. The lobby area ranged from 30 to 75 micro/hr (See Figure 5 for first floor results).

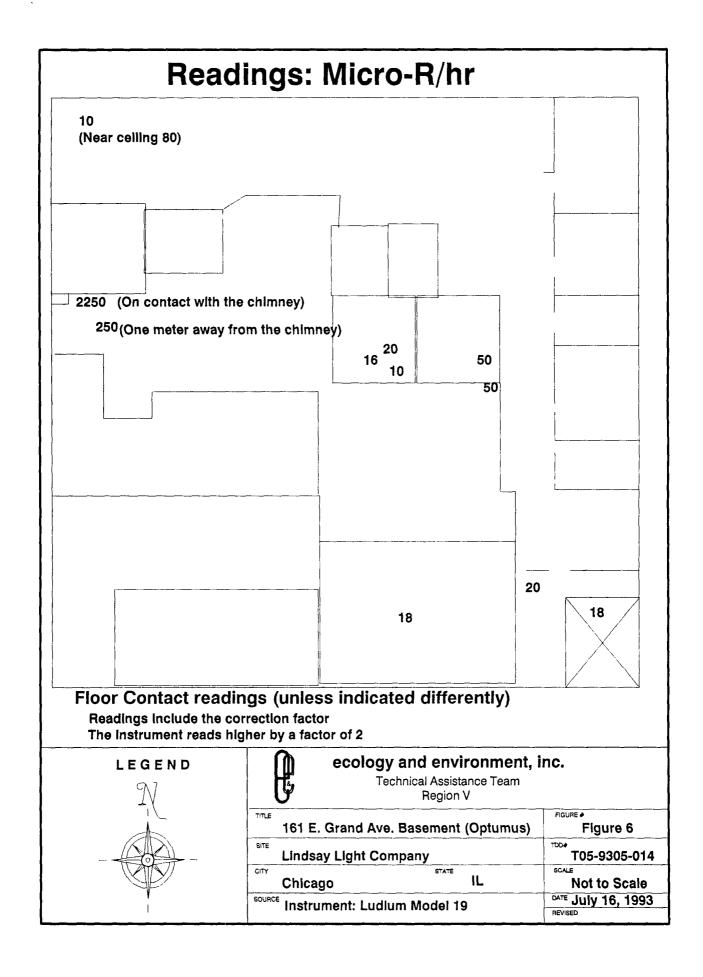
At 2000 hours, group 1 began to survey the basement area. The area of concern in the basement with the highest gross exposure rate was measured on contact with a concrete plug in the chimney. The micro-R survey indicated level of 2,250 micro-R/hr at contact of the chimney and 250 micro-R/hr at one meter away from the chimney (See Figure 6 for basement results).

At 2040 hours, the OSC, ERT member, ARD representatives, IDNS representatives, and TAT went over the results with the building spokesman Ron Steele. It was suggested that due to the high readings from the chimney, the janitor's supplies near the chimney should be immediately relocated. After the meeting the groups left the site at 2100 hours.

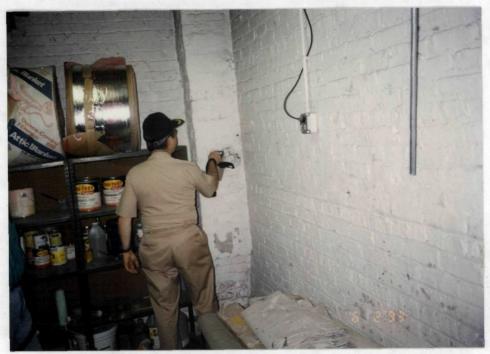
DESCRIPTION: Reading at contact of the chimney (2250 uR/hr). The

chimney is located near the northwest section of the basement.

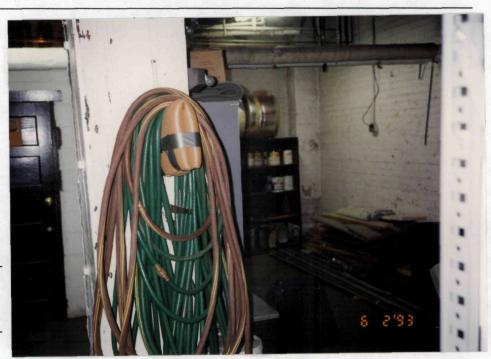
DESCRIPTION: The janitors area located near the chimney. One meter away from the chimney the readings were reduced by a factor of 10.

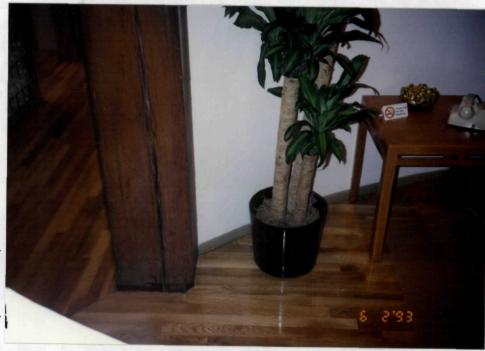
DESCRIPTION: Reading at contact near the receptionist area

(receptionist is to the north (left of the photo).

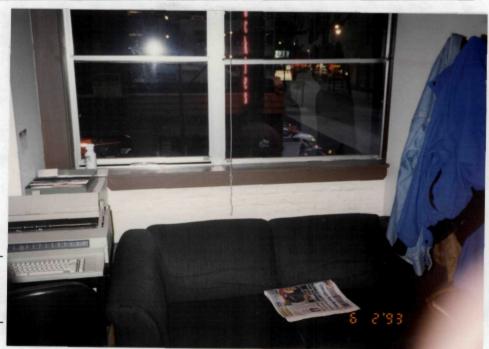
DESCRIPTION: The Second floor photo of the area where the window

area had a reading of 80 uR/hr.

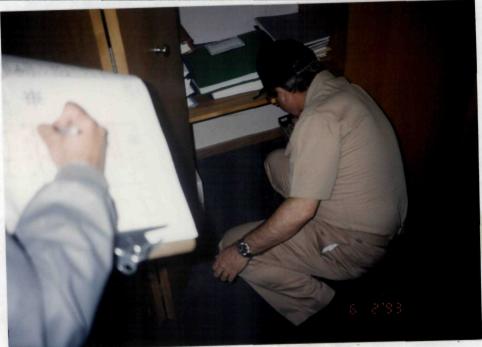
DESCRIPTION: Reading at contact near the northeast corner of the

third floor.

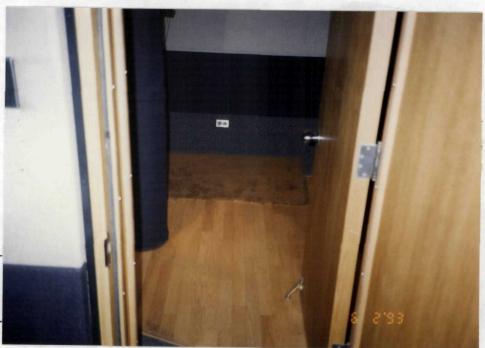
DESCRIPTION: The third floor sound booth that had readings of 95 uR/hr on contact with the floor. The sound booth is located near the southwest side of the third floor.

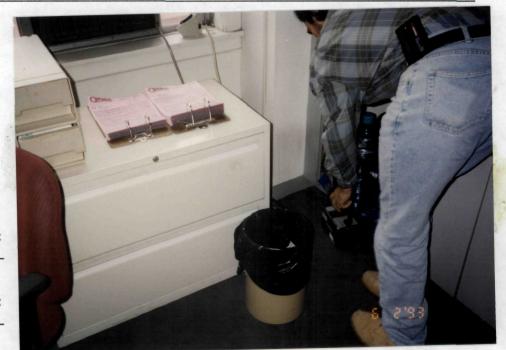
DESCRIPTION: The third floor northeast office on contact with the

east wall. Readings were 10 uR/hr.

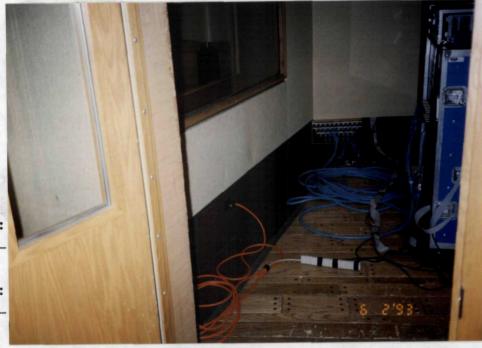
DESCRIPTION: The reading was collected inside a sound booth located on the fourth floor and is near the southwest section of the floor.

The reading was 200 uR/hr.

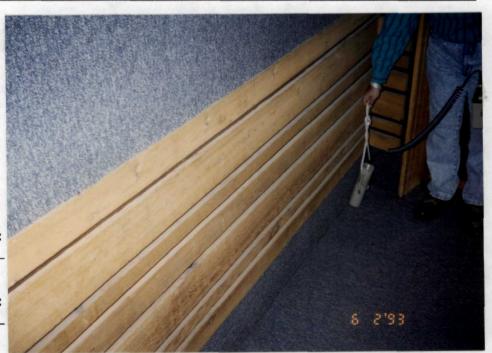
DESCRIPTION: A hallway leading into a sound booth located on the fourth floor. The reading at that point was 350 uR/hr.
